Contract #: 04-0120F4Cty: SF/ALA Rte: 80 PM: 13.2/13.9File #: 1.28**WELDING INSPECTION REPORT****Resident Engineer:** Casey, William**Address:** 333 Burma Road**City:** Oakland, CA 94607**Report No:** WIR-030039**Date Inspected:** 12-Sep-2013**Project Name:** SAS Superstructure**OSM Arrival Time:** 700**Prime Contractor:** American Bridge/Fluor Enterprises, a JV**OSM Departure Time:** 1730**Contractor:** American Bridge/Fluor Enterprises, a JV**Location:** Job Site**CWI Name:** Bernie Docena**CWI Present:** Yes No**Inspected CWI report:** Yes No N/A**Rod Oven in Use:** Yes No N/A**Electrode to specification:** Yes No N/A**Weld Procedures Followed:** Yes No N/A**Qualified Welders:** Yes No N/A**Verified Joint Fit-up:** Yes No N/A**Approved Drawings:** Yes No N/A**Approved WPS:** Yes No N/A**Delayed / Cancelled:** Yes No N/A**Bridge No:** 34-0006**Component:** SAS Tower**Summary of Items Observed:**

ESW Repair excavation

RWR-201308-004

ESW S-043, Location "T"-Face A:

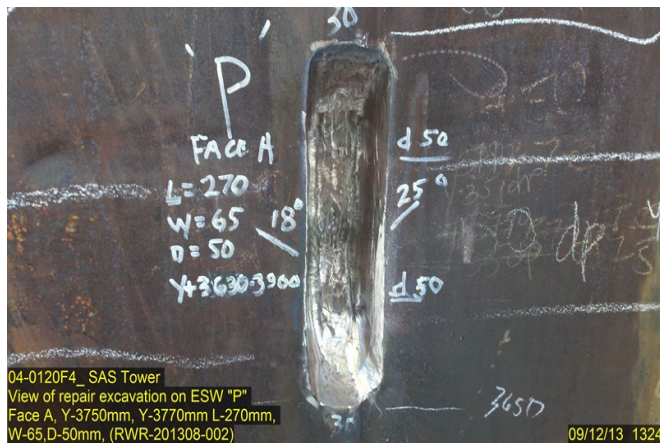
The QA Inspector observed ABF welder Wai Kit Lai (WID-2953) performing excavation of ESW "P" Face A @ Y-3750mm, Y-3770mm to verify indications observed during Ultrasonic Testing pulse/echo & pitch/catch. The repair information and rejectable indication is described in Request for Weld Repair (RWR) 201308-002. Mr. Lai was performing the excavation using an air carbon arc gouging and a grinder. The repair is being performed on Face A, since a significant planar indication was verified and removed on Face B at this Y location. Mr. Lai was instructed by ABF QC Inspector Bernie Docena to notify him if indications are visible to allow QC/QA time to inspect the excavation. Location of the repair is as follows:

Weld excavated at 50mm dp- No indications observed.

Excavation Length (Y=3630mm~3900mm) L-280mm

W= 65mm

D= 50mm

After grinding to bright metal the QC Inspector performed MT testing of the excavation. The QC Inspector stated the excavation appears to be free of discontinuities and he would complete ABF daily inspection report and magnetic particle testing report to detail the findings. See TL-6028 for additional details on items inspected on this date. Mr. Lai was later observed performing Shield Metal Arc Welding (SMAW) on the repair excavation mentioned above. The preheat was being held to over 350° Fahrenheit using the Miller ProHeat 35 with heat induction blankets. The welder was using 4.0mm diameter electrode (E7018-1 HR4) per ABF Welding Procedure Specification (WPS) ABF-WPS-D15-1000-Repair Rev.3. ABF QC Inspector Bernie Docena performed welding parameters verifications at random intervals throughout the shift. The welding observed appeared to be in compliance with the WPS noted above.
